## ANALYSIS OF THERMITE RAIL JOINT DAMAGE IN CURVE

### SECTION 3 OF LRT JAKARTA

Heriyanto Wibowo<sup>a</sup>, Insan Kamal<sup>b</sup>, Dhea Ananda Safitri<sup>c</sup>

<sup>a,b,c</sup>Institut Transportasi dan Logistik Trisakti, Jakarta, Indonesia

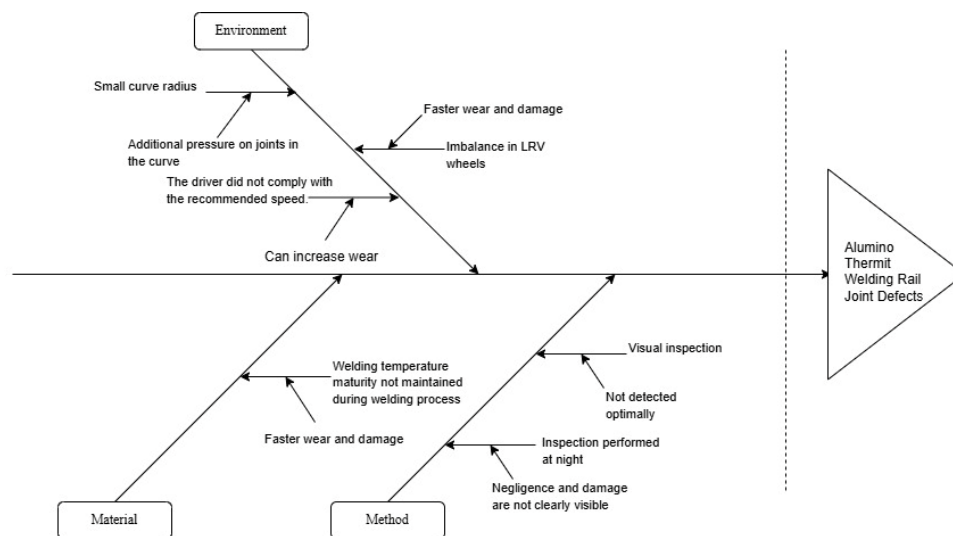
Fig 1. Diagram Fishbone

Based on the fishbone analysis diagram that has been made, it can be seen that with this fishbone analysis theory, namely by identifying and finding various causes of problems related to damage to Alumino Thermit Welding rail joints. It can be determined that the main cause that causes damage to the Alumino Thermit Welding (ATW) rail connection on the section 3 curve of the Pulomas Station plot - South Boulevard Station of the Jakarta LRT, namely:

1. Weld maturity and temperature control, greatly affect the durability of the joint. Imperfections in these processes can lead to structural weaknesses that accelerate damage, especially in curved areas.
2. Inspections were conducted only visually and were conducted at night under limited lighting conditions, potentially missing damage or minor changes to the joints.
3. Driver non-compliance with the recommended speed when crossing rail curves is a significant factor. Speeds in excess of recommended limits can increase stress and wear on rail joints, accelerating the onset of damage.
4. Operational conditions such as too small a curve radius and train wheel imbalance put additional stress on the rail joints.

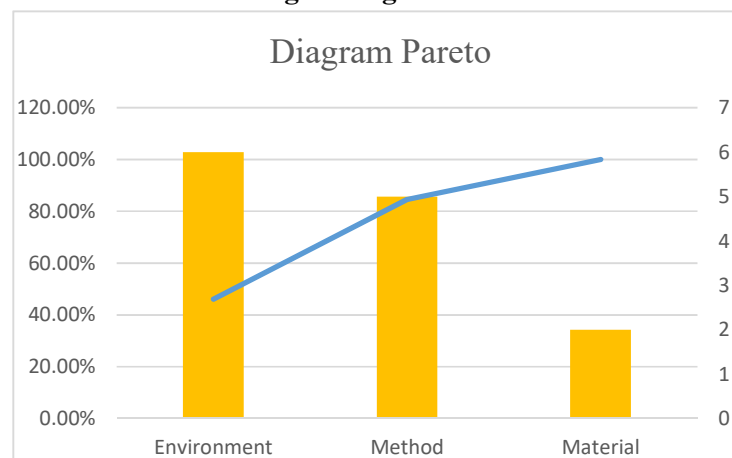
**Fig 2. Diagram Pareto**

The frequency of causes of damage is based on data collected from interviews with several informants. The following is a detailed explanation of the diagram:

1. Environment has the highest frequency (6), which means this factor is the main cause of the analyzed problem. It accounts for about 46.15% of the total occurrences.
2. Method is the second most significant factor, with a frequency of 5, which accounts for 38.46% of the total occurrences.
3. Material has the lowest frequency (2), and accounts for 15.38% of the total occurrences. The cumulative line shows that by improving the Environment and Method aspects, about 84.61% of the problems can be solved. Therefore, improvement measures should focus on these two factors to get the most significant results.
