# ACCESSIBILITY ANALYSIS OF INTERMODAL SHIFT IN THE BLOK M TRANSIT-ORIENTED DEVELOPMENT AREA (STUDY CASE: MRT STATION BLOK M BCA AND TRANSJAKARTA BUS STOP BLOK M)

**Abstract:** Blok M BCA MRT Station and Blok M Transjakarta Bus Stop, have not been fully integrated properly, hampering passenger movement. This study aims to analyze the accessibility of intermodal displacement in the Transit-Oriented Development Blok M. The method used is qualitative descriptive approach. Data collection by triangulating observation techniques, questionnaires, and documentation to MRT and Transjakarta Blok M passengers. The results of the analysis, it can be concluded that the accessibility value of intermodal movement in the Transit-Oriented Development Blok M area is 3.0%. This value indicates that the accessibility and completeness of facilities in this area are still not good for users who want to switch modes. The assessment based on user perceptions shows that there are several indicators that need to be improved to achieve an optimal accessibility value.

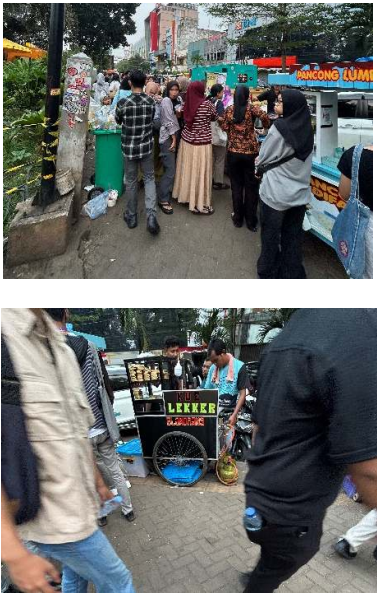
| No. | Indicator | Observation Results | |
|---|---|---|---|
| 1 | Pedestrian Path | The condition of the pedestrian path is still inadequate because the size that should be 2.85 meters becomes 1.60 meters due to the use of the Pedestrian Path by street vendors for selling places. | |

1. The pedestrian path is considered to still need improvement with a score of 2.2, this value indicates that the pedestrian path is not in good condition. The existing pedestrian path is often hampered by the presence of street vendors, especially in the afternoon, as well as the presence of quite a lot of stairs, which are a barrier for users, especially those with limited mobility.

1. Obstacles on the pedestrian path such as the presence of street vendors and the lack of supporting facilities such as canopies, lighting, and guiding blocks that are not fully functional must be managed and reorganized to ensure that there are no obstacles that hinder pedestrian activities.

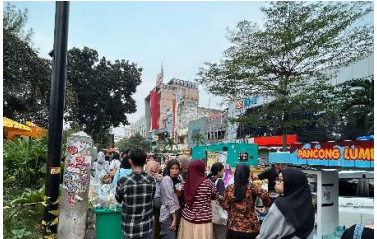
| No. | Indicator | Observation Results | |
|---|---|---|---|
| 2 | Canopy | There is no canopy on the pedestrian path, so passengers are still exposed to rainwater when it rains and sunburned when it is hot. | |

2. Pedestrian support facilities such as canopies are currently considered to be in poor condition, as reflected in the average score of 2.7. On the pedestrian path that is the main link between the two modes of transportation, the absence of a comprehensive canopy results in users being exposed to direct rain or heat, so the improvement or addition of canopies along the path is very necessary.

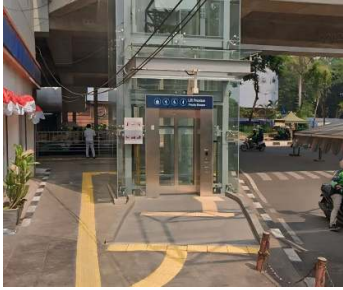
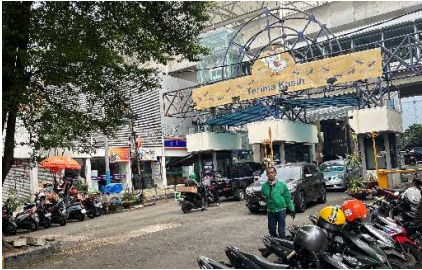
| 4 | Lift | There is an elevator at only one point with access conditions that are difficult to reach for friends with disabilities. | |

4. The availability and condition of the elevator still requires further attention, as shown by the average score of 3.20, this value indicates the availability and condition of the elevator is not good. The management and rearrangement of this elevator needs to be done because passengers feel the size of the elevator is limited which results in often experiencing long queues, and access is less friendly for users with disabilities.

2. Other supporting facilities such as elevators and ramps need to be improved in quality and quantity. Improvements to elevator access and the addition of an elevator at the Blok M Transjakarta bus stop for users with disabilities are needed. Repositioning of ramps and rearrangement of pedestrian areas are also needed to ensure better accessibility, especially for users with disabilities.

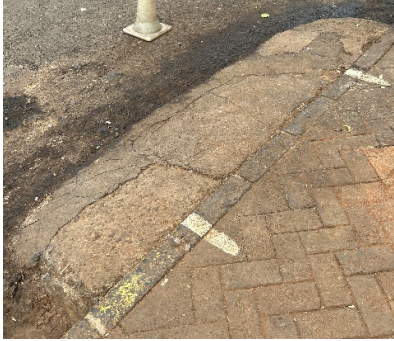
| 5 | Ramp | Non-strategic placement of ramps on the mode shift path. | |

- score of 2.5. The existing ramps are not always easily accessible or are even covered by street vendors, making their use suboptimal.
6. The availability of wayfinding is still in poor condition. The spacing of wayfinding with an average score of 3.4 indicates that it is not evenly distributed throughout the mode shift area. Existing wayfinding is only available at a few points, and does not adequately cover many important areas.

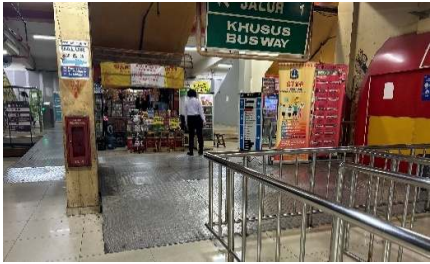
| 6 | Wayfinding | Not available on the transfer line from the TransJakarta bus stop to the MRT station, unlike the reverse transfer. | |

3. The addition and more even distribution of wayfinding and signage will help users navigate the transfer area more easily. Improvements to these information facilities will help improve user orientation and ease of switching modes.

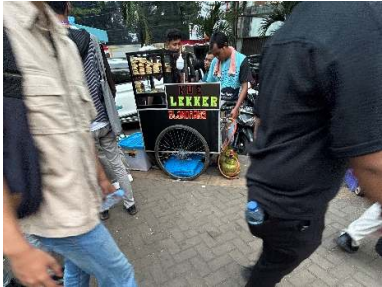
| 8 | Guiding Block | Not functioning properly due to the presence of street vendors for selling. | |

8. Other supporting facilities for friends with disabilities (blind), namely guiding blocks, are still considered in poor condition with an average score of 3.5. Especially in the pedestrian path and mode transfer area of the Blok M Transjakarta bus stop.
